AN EXPERIMENTAL STUDY TO DETERMINE THE REDUCTION
IN ULTIMATE BENDING MOMENT OF A COMPOSITE PLATE
DUE TO AN INTERNAL DELAMINATION

THESIS

December 1977

MASTER OF SCIENCE IN AERONAUTICAL ENGINEERING

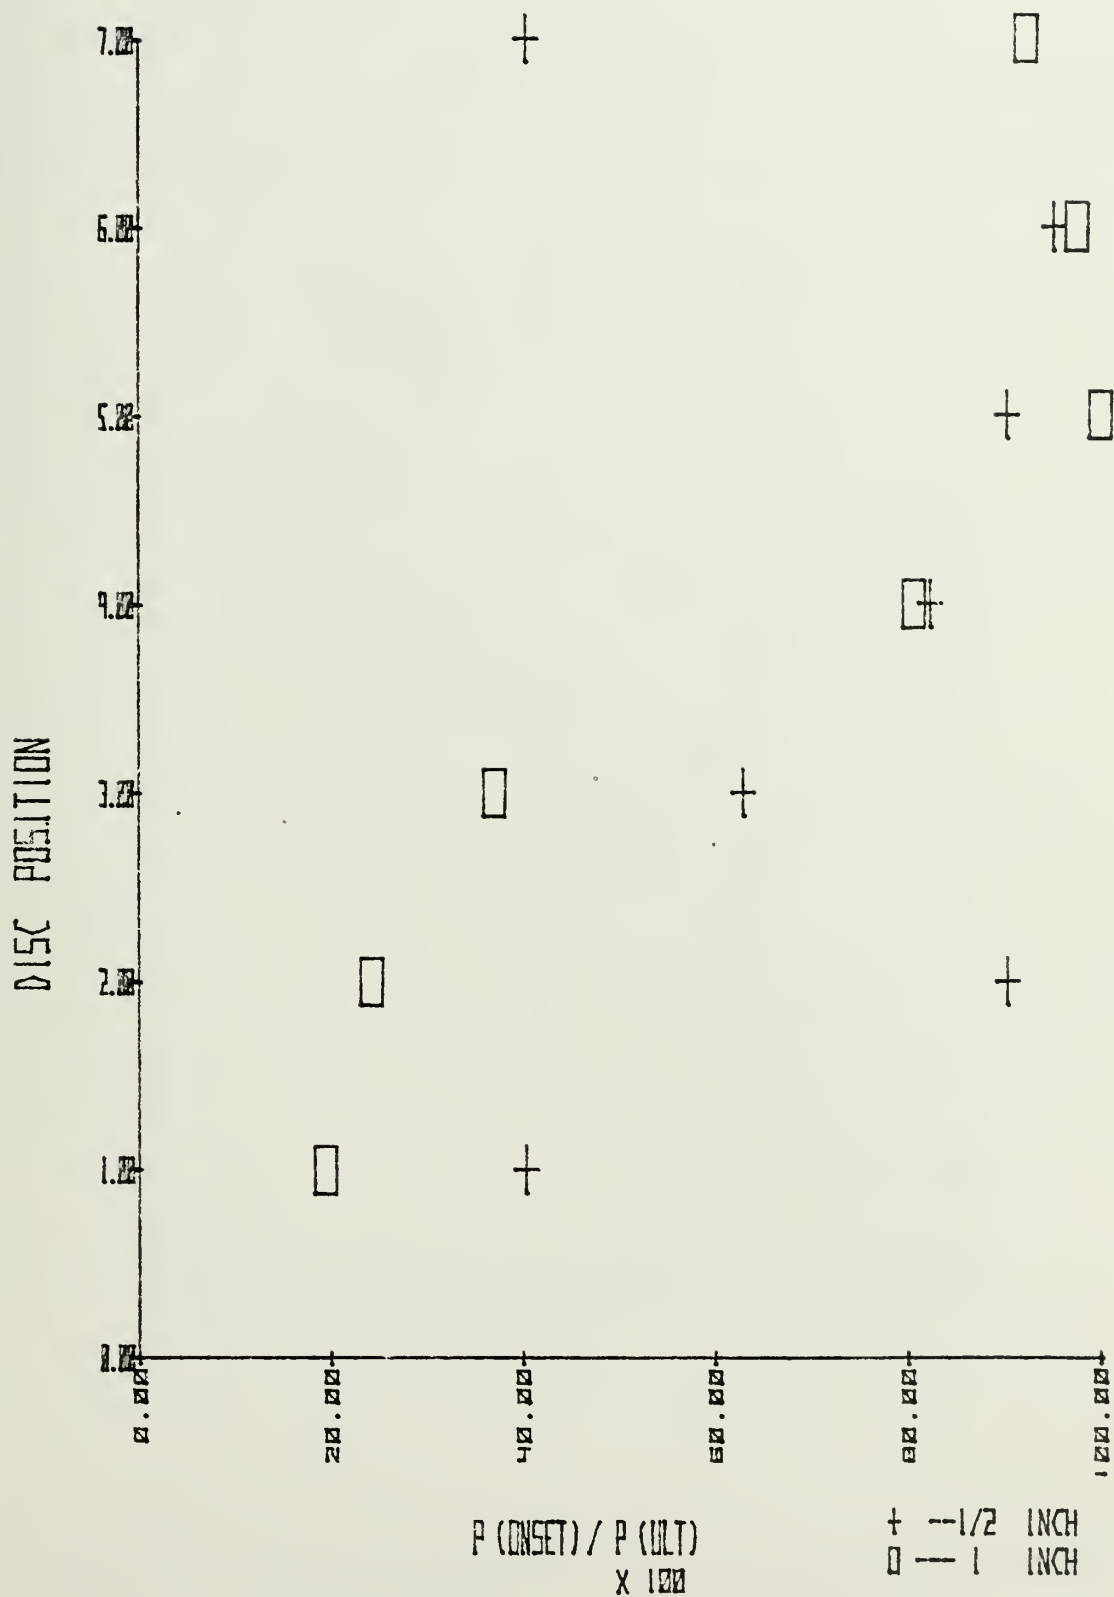
Fig 9 - ONSET OF PROPAGATION

Another area of concern was the onset of the propagation of the delamination beyond the original built-in, internal defect. This task proved extremely difficult in most cases, since the tests consisted of only one loading cycle, and a detailed inspection of the specimen during the testing was not possible. However, in some cases, especially when the internal delamination was near an outer surface, the onset of the delamination propagation could be detected visually. The propagation of the delaminations was also found to be characterized by cracking noises, probably caused by the breakdown of the epoxy matrix. These noises occurred even when no outward buckling or cracking was visually apparent on the outer surfaces. The onset of the delamination propagation was noted as closely as possible and recorded. The load at which onset occurred is plotted as a function of flaw position and is presented in Figure 9. It is evident from Figure 9 that the onset of the propagation of the delamination occurs at a much lower load level when the delamination is located in the portion of the specimen that experiences a compressive load. The data scatter which is apparent in Figure 9 is attributable to the difficulty in establishing the exact onset of the propagation.
